# Boston's Open Space

1987  
PARK EVALUATION  
&  
SITE SUMMARIES

EVALUATION OF  
CITY OF BOSTON  
PARK AND RECREATION LAND

NEIGHBORHOOD OF ALLSTON/BRIGHTON

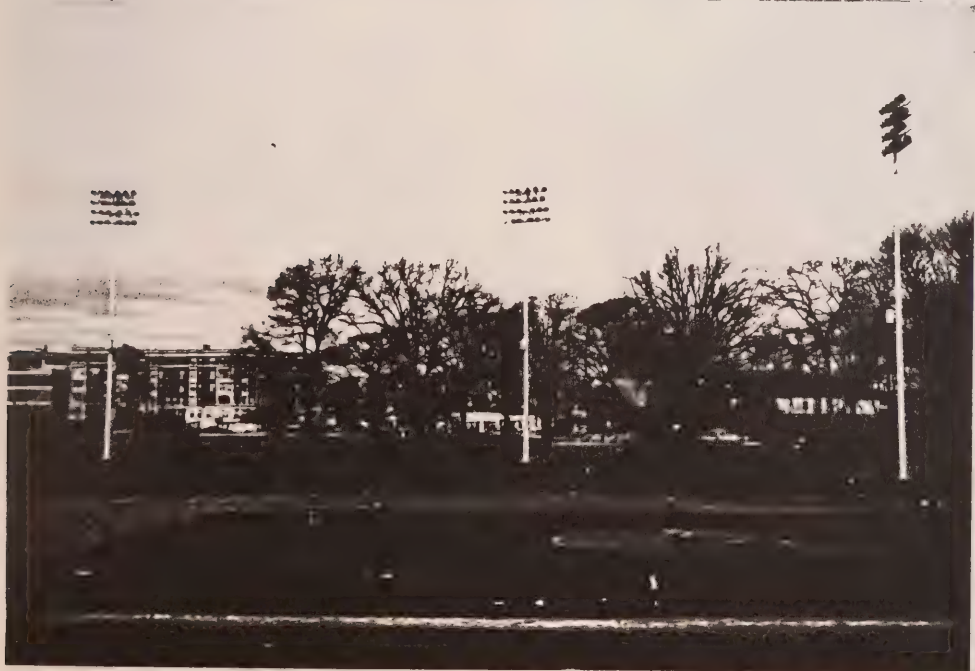
### **Site Photograph 3**

Natural stand of trees provides pleasant setting for building and a strong statement for the park.

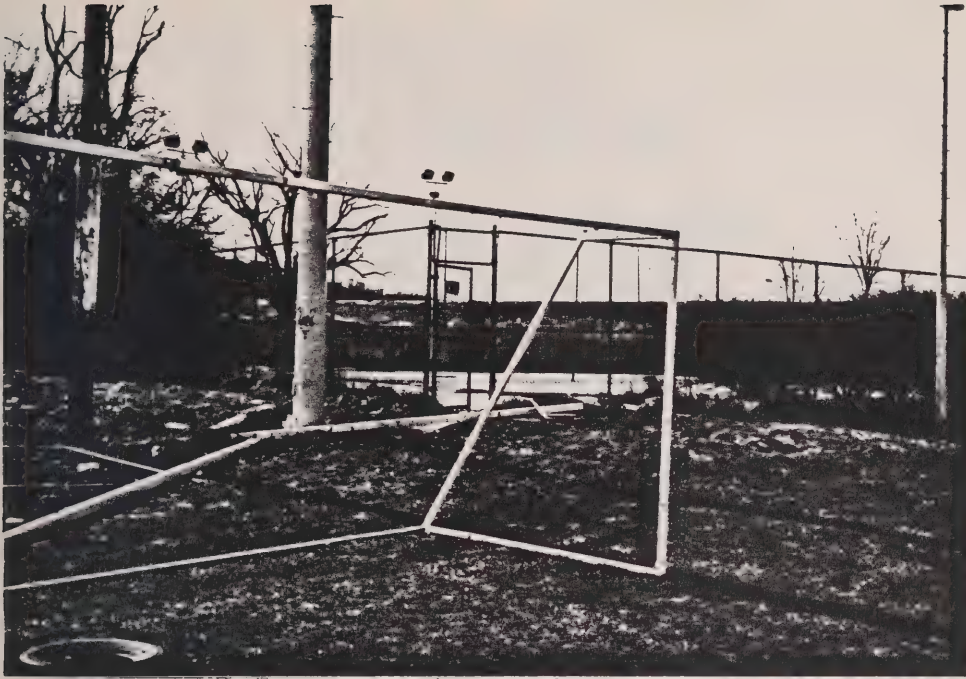
#### Site Photograph 4

Entrance to tennis courts. Debris should be removed.

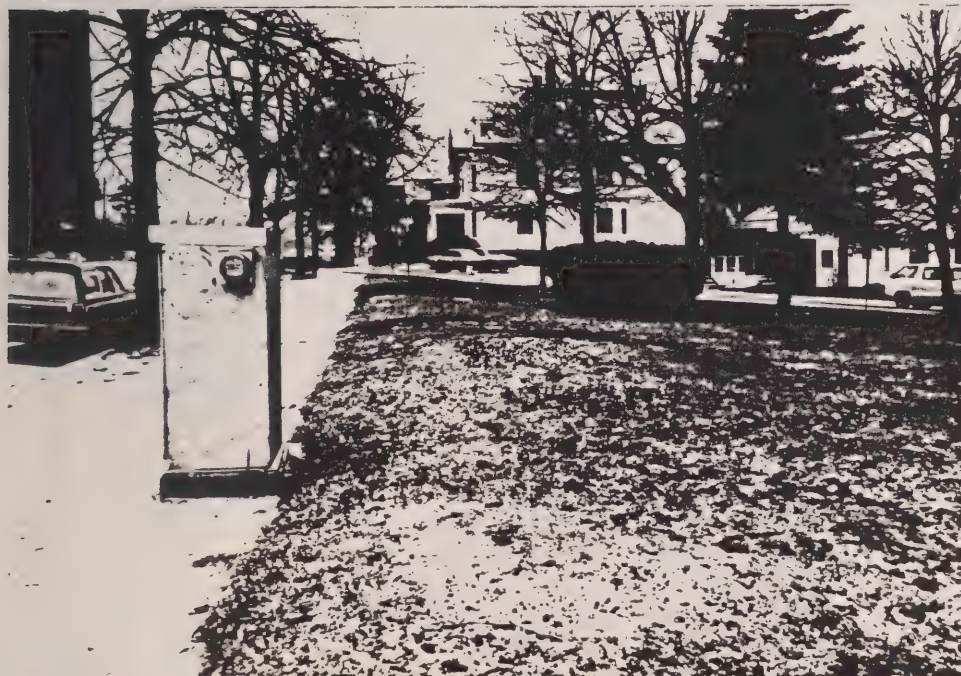
**Site Photograph 2**

View along Cambridge  
Street. Flower bed in  
middle ground.

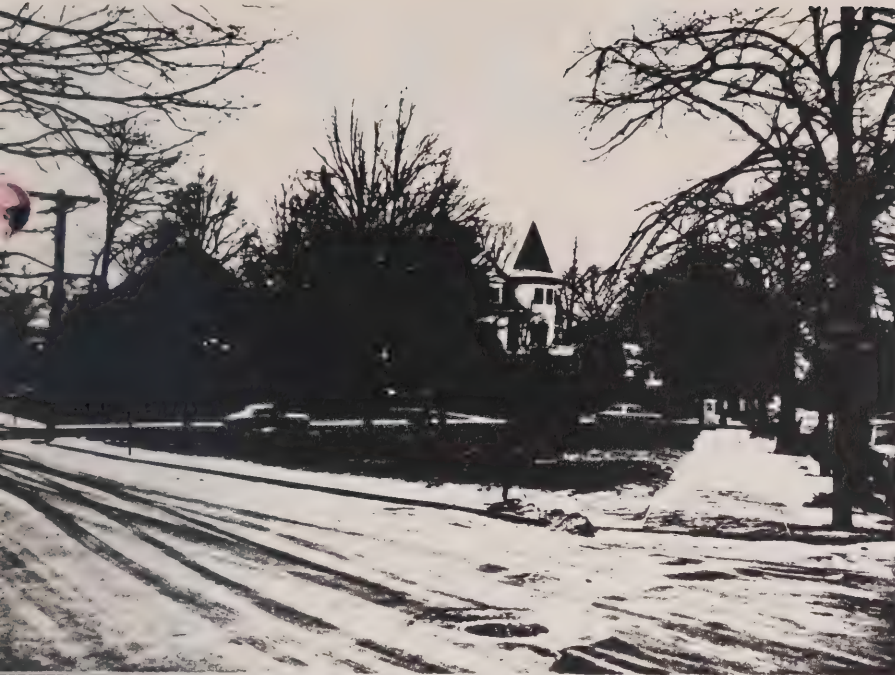
**Site Photograph 4**

View along Cambridge Street shows simple straightforward layout of space.

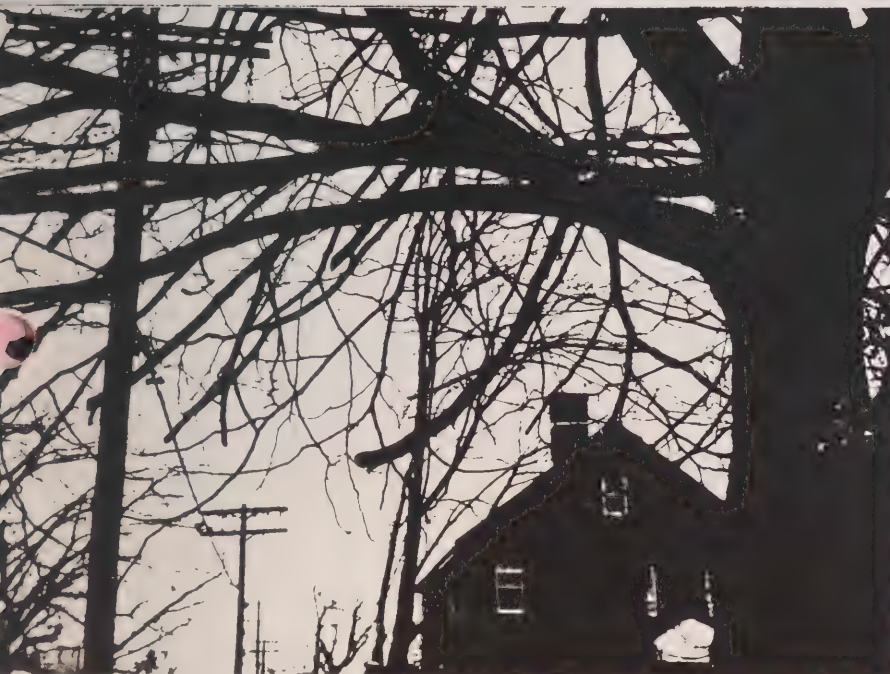
**Site Photograph 5**

Poor pruning of tree.

DESIGN CONSIDERATIONS:	
LAYOUT/ORGANIZATION OF SPACE	Simple & easy to maintain
USE OF PLANT MATERIALS	good - tree. used around edge & spine as focal point
APPROPRIATENESS OF PARK FUNCTIONS TO NEIGHBORHOOD	
BARRIER FREE DESIGN	cuts in sidewalk
DRAINAGE CONDITION	good
DESIGN-RELATED MAINTENANCE ISSUES	-
VANDALISM	none
VACANT PARCEL TO SOUTH, EAST	-
VISIBILITY AND SAFETY:	
VISIBILITY INTO SPACE	good
VISIBILITY OUT FROM SPACE	good
HIDDEN CORNERS IN SPACE	none
CONDITION ASSESSMENTS:	
STANDARD PARK BUILT ELEMENTS	-
SPORTS FACILITIES	-
PLAYGROUNDS	-
BUILDINGS	-
NATURAL PARK ELEMENTS	tree in good condition but badly pruned

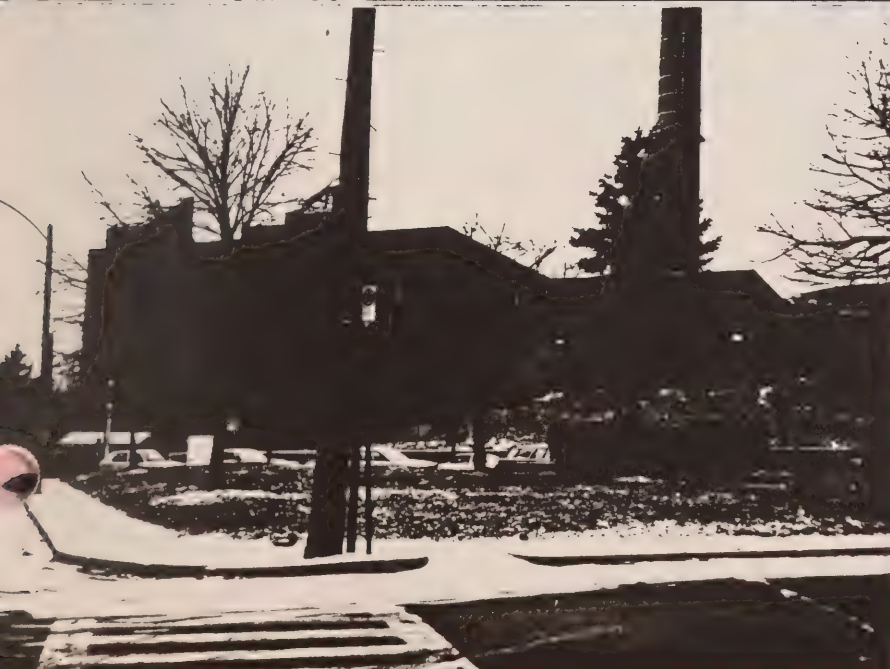
**Site Photograph 6**

View from Murdock Street.

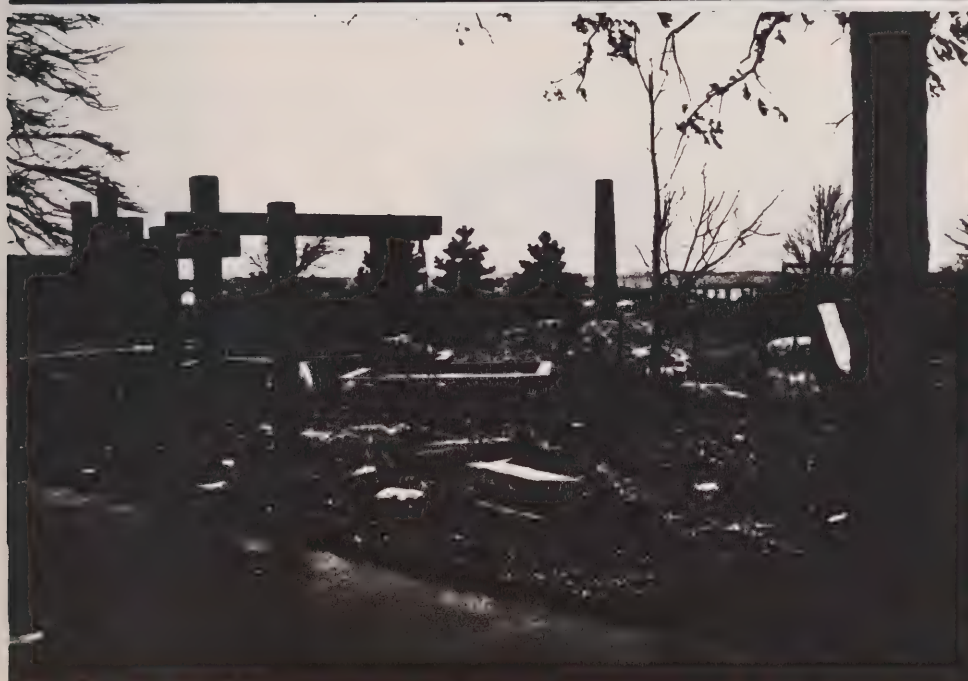
### **Site Photograph 2**

Playground - note  
absence of curbing  
and surface material.

The playground is in fair to poor condition. Equipment is vandalized and broken and the playground surface is rocky and hazardous.

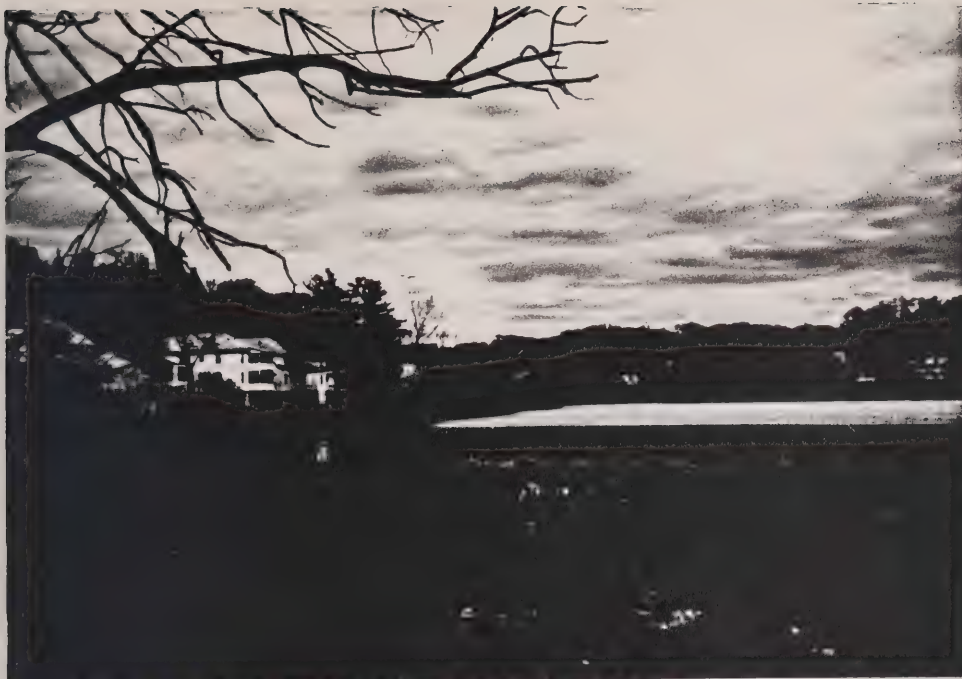
### **Site Photograph 1**

View across pond - shows scenic value of landscape, with ducks and cattails.

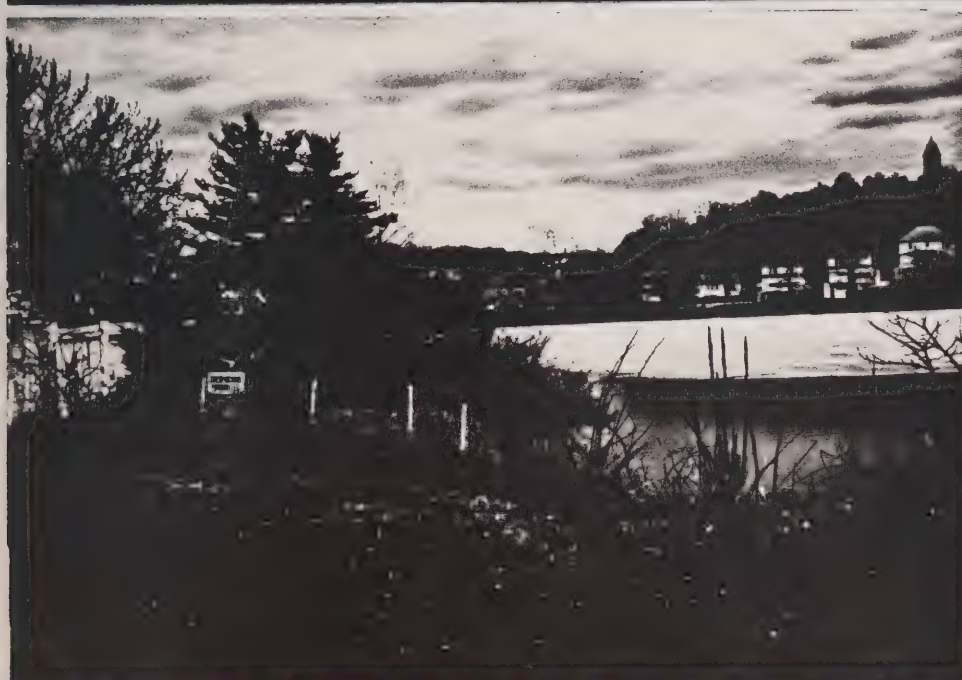
### **Site Photograph 2**

Property line of area unclear. Weed species to right should be removed.

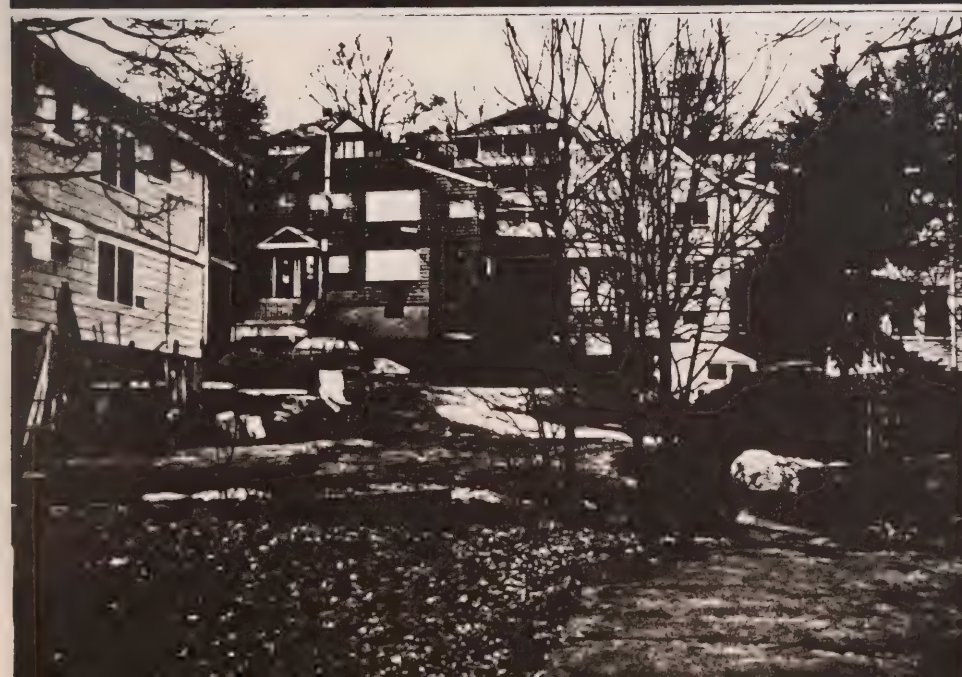
### **Site Photograph 3**

R.O.W. access should be more clearly defined.

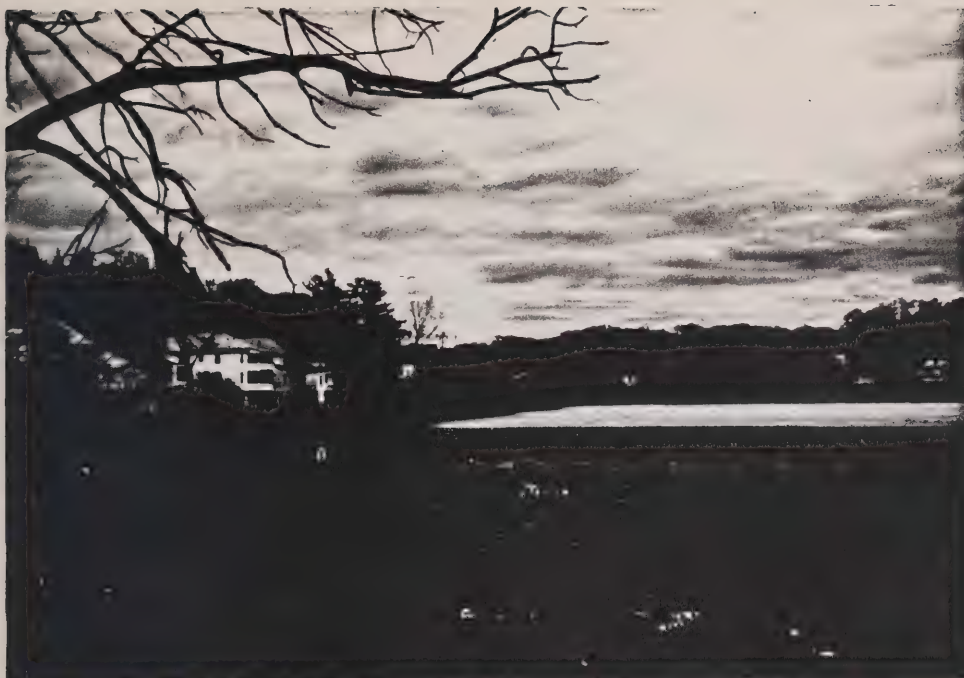
### **Site Photograph 1**

View across pond - shows scenic value of landscape, with ducks and cattails.

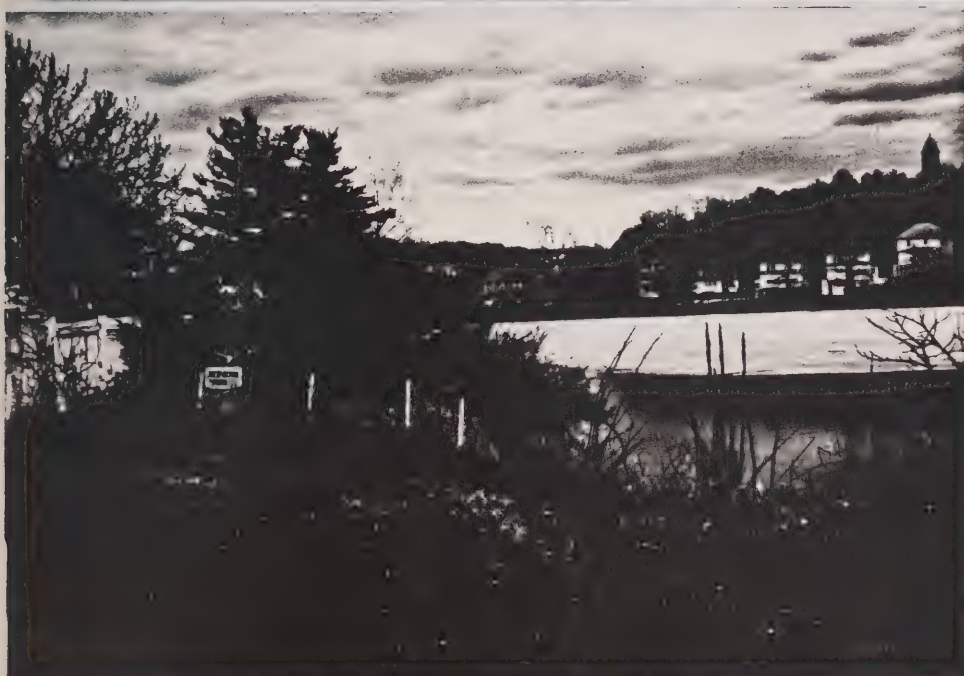
### **Site Photograph 2**

Property line of area unclear. Weed species to right should be removed.

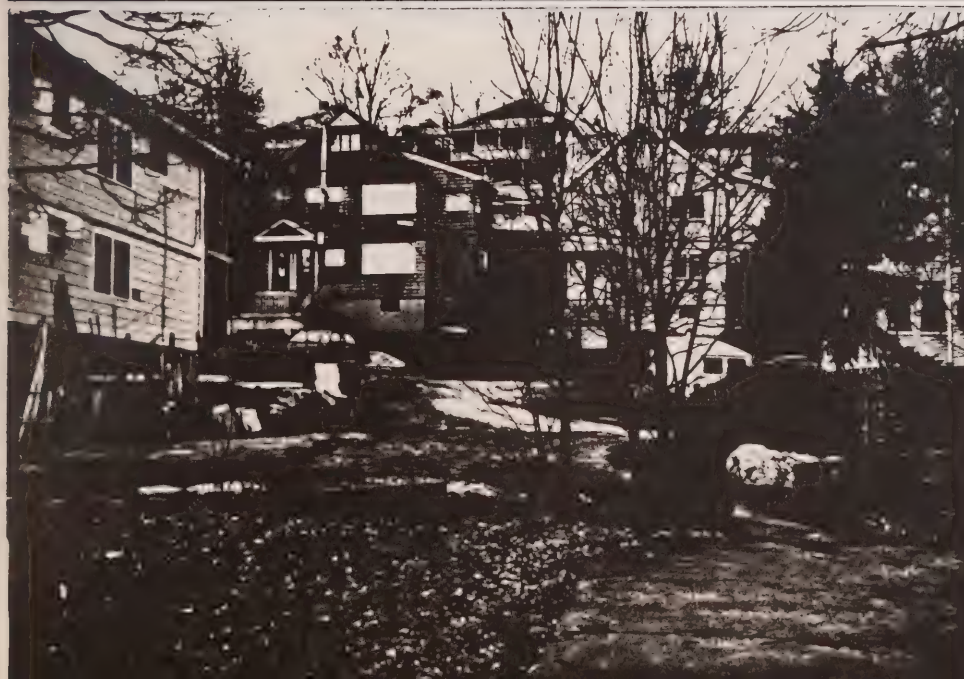
### **Site Photograph 3**

R.O.W. access should be more clearly defined.

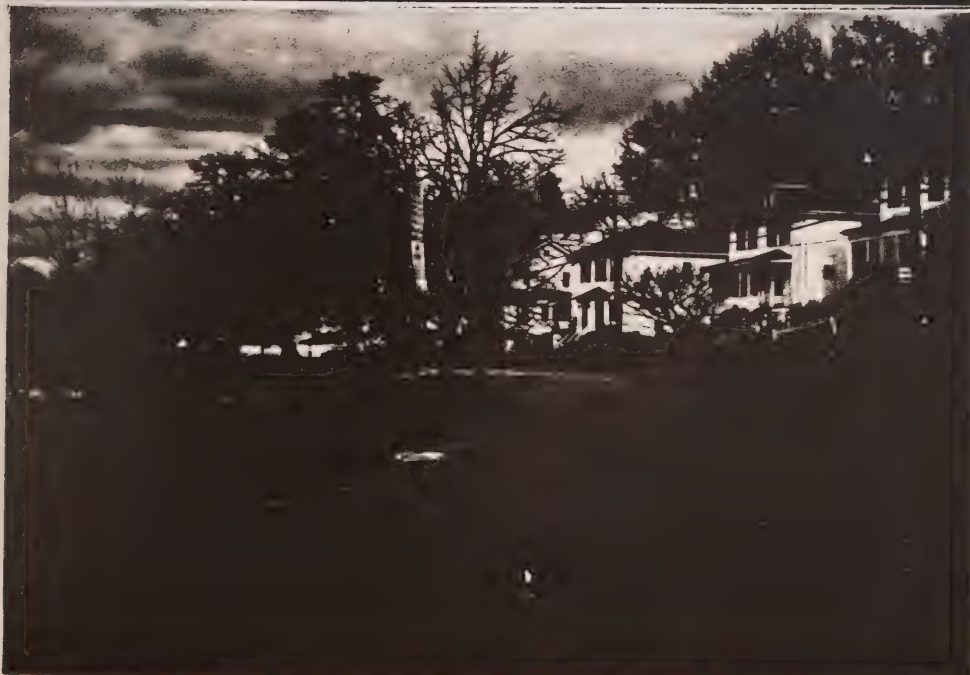
**Site Photograph 6**

Fine row of linden trees. Curb would more clearly define sidewalk.

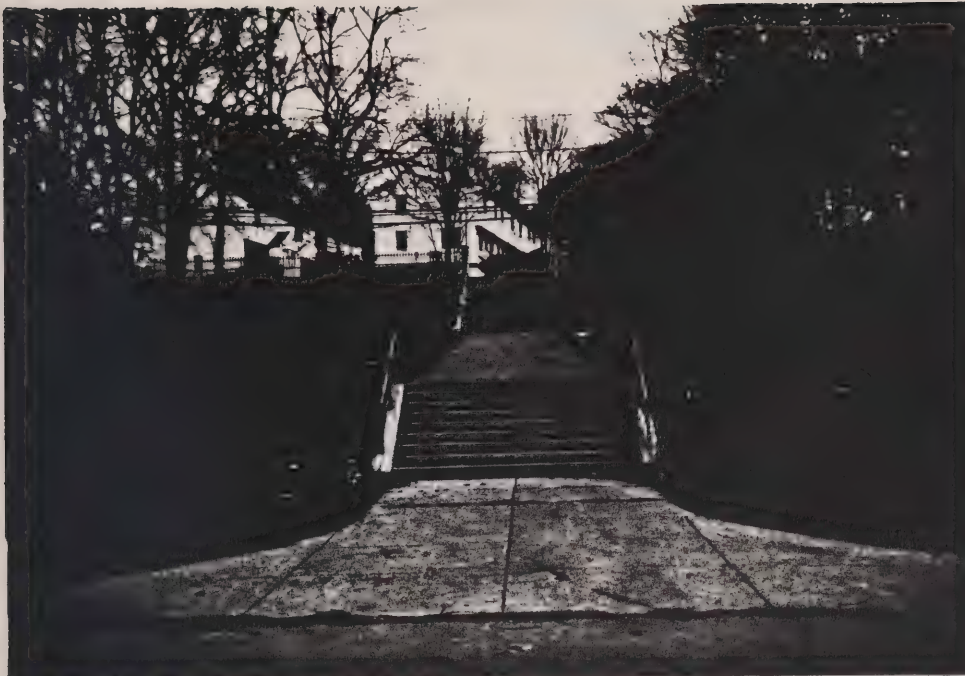
**Site Photograph 1**

View up hill, showing steep slope of site. Steps in good condition. Note good mature trees at edge.

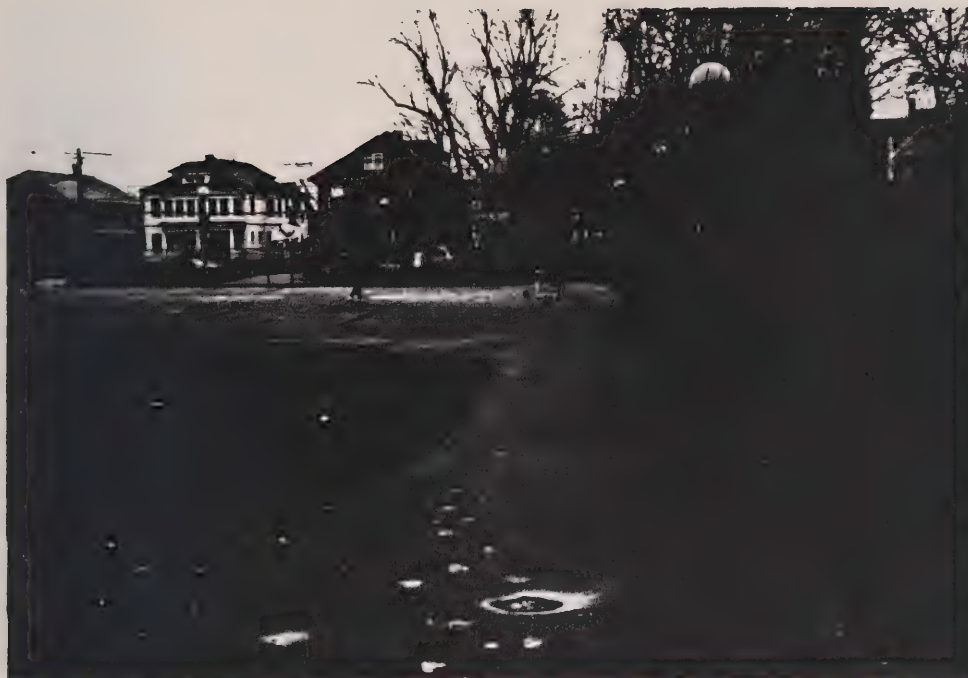
**Site Photograph 1**

View down slope and into park. Shows typical neighborhood.

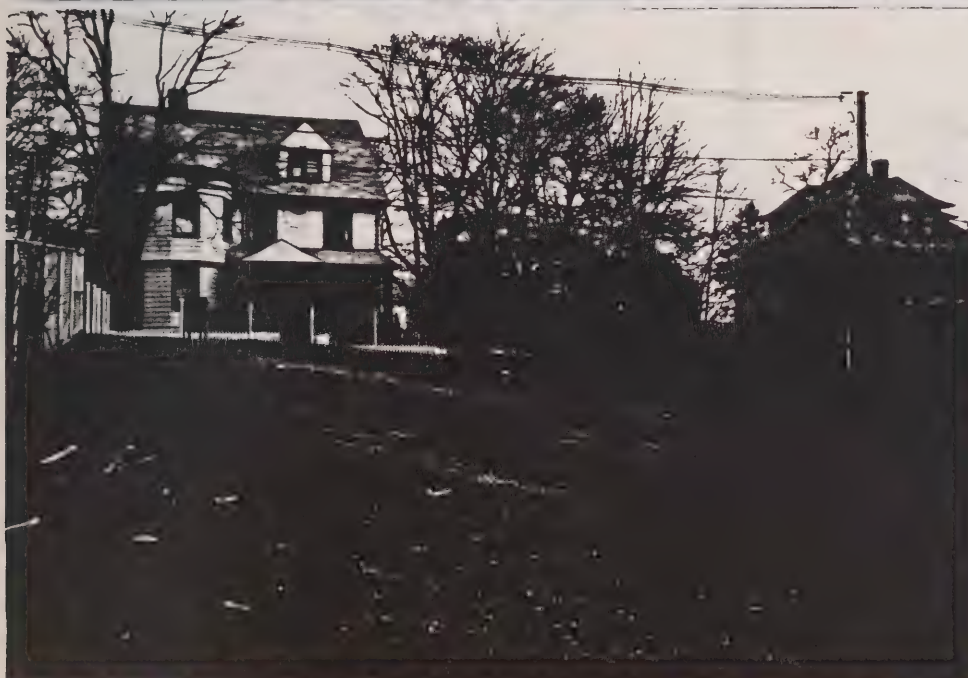
**Site Photograph 2**

Shows how bollards serve as effectively as chain link fence to define boundary and control vehicular access.

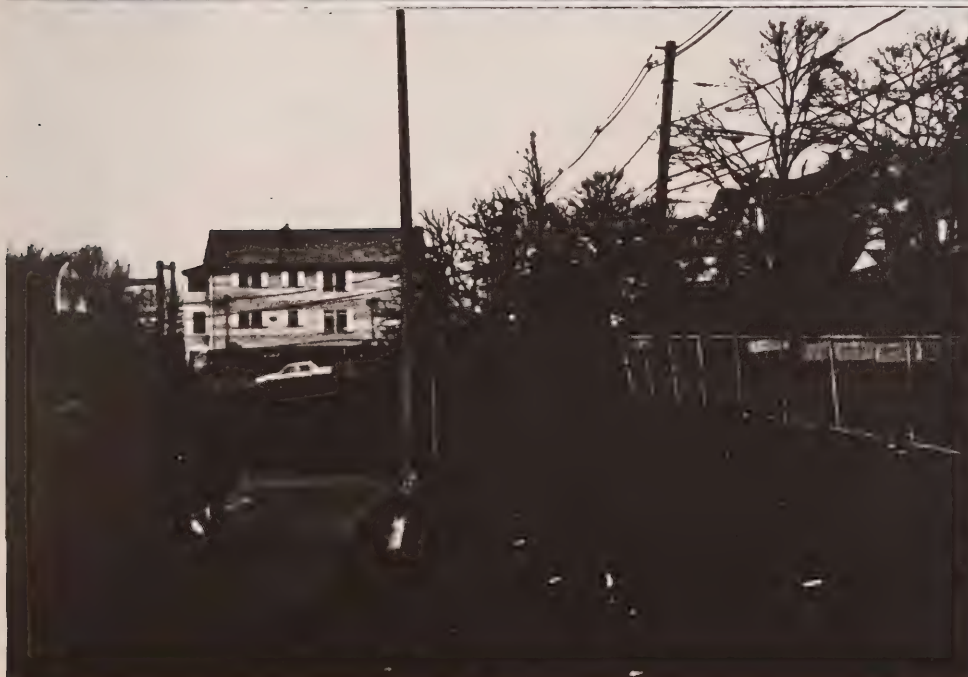
**Site Photograph 3**

Slope showing "desire lines" or undesignated paths. Topography makes grassed area difficult to use.

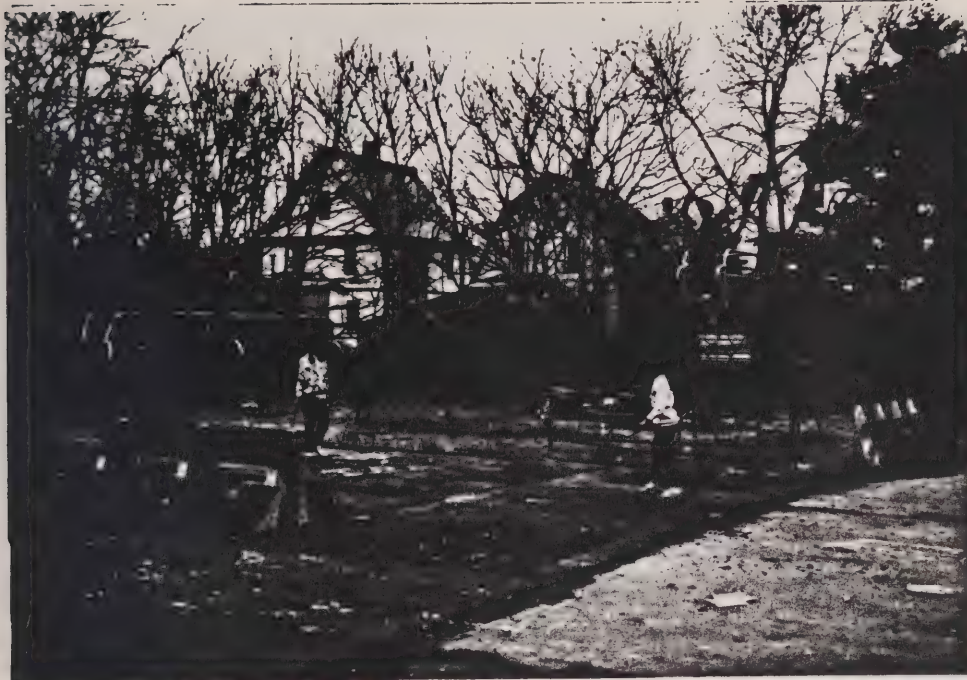
### **Site Photograph 1**

Playground.

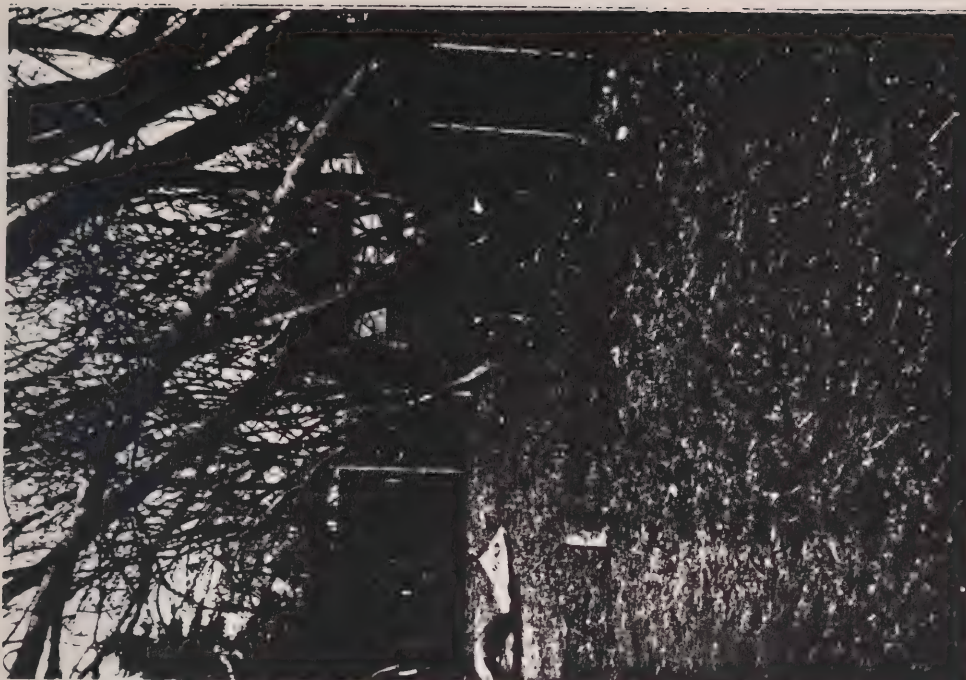
**Site Photograph 4**

Typical trees at edge of playground. Badly needs removal of dead wood.

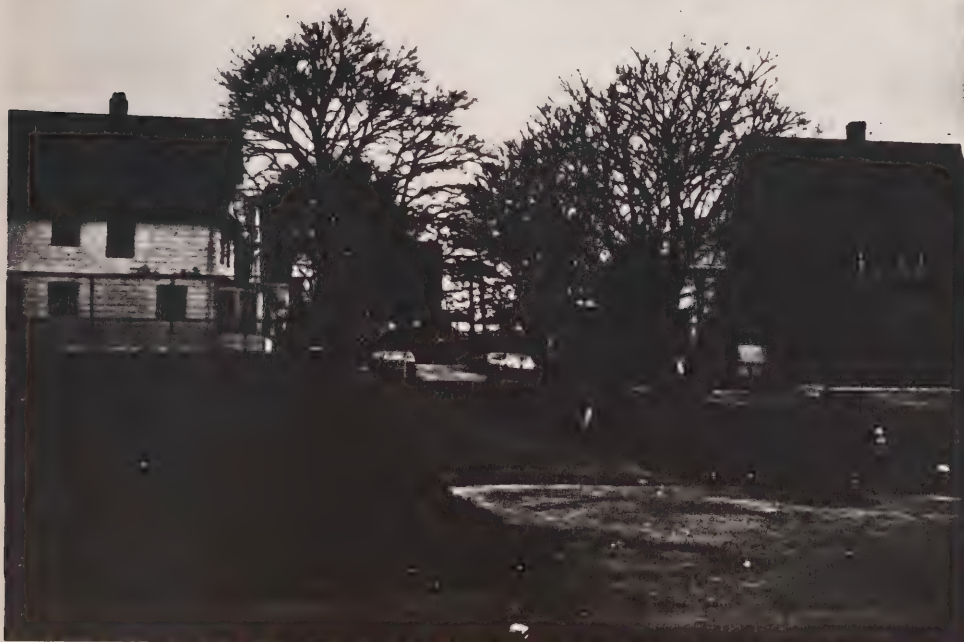
**Site Photograph 5**

Access from Sorrento Street. Trees contribute to character of space. Open space to left used for free play.

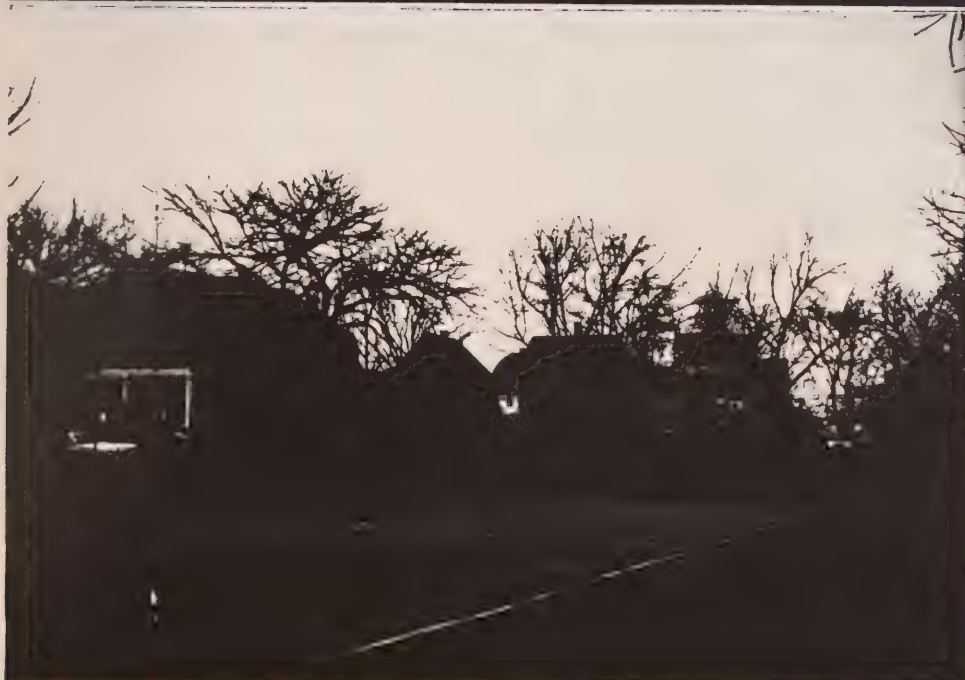
**Site Photograph 6**

Basketball.

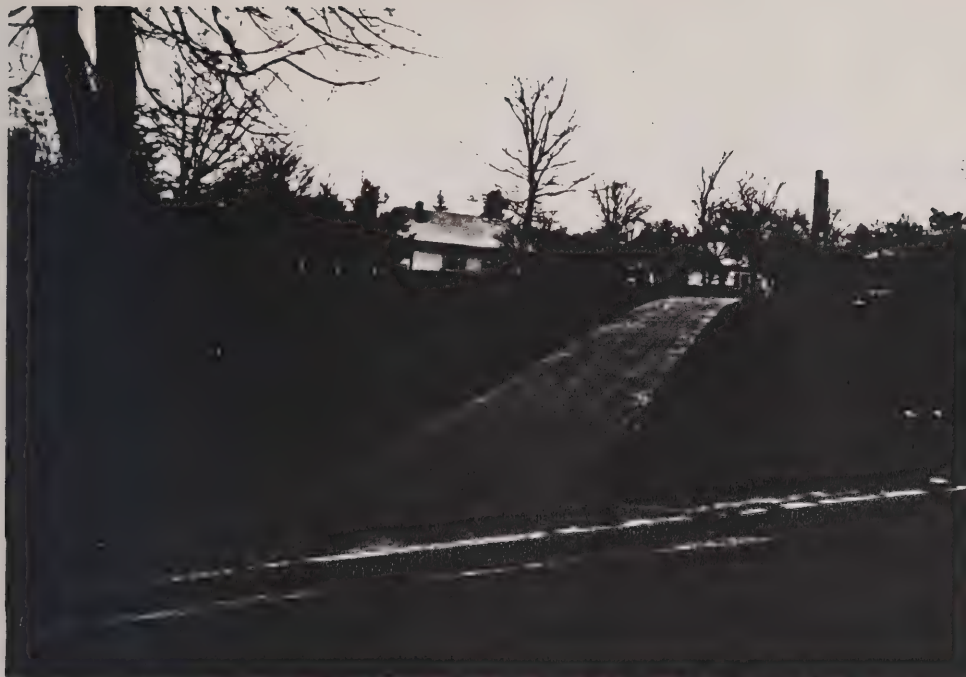
**Site Photograph 1**

View into park from  
Lyne Road.

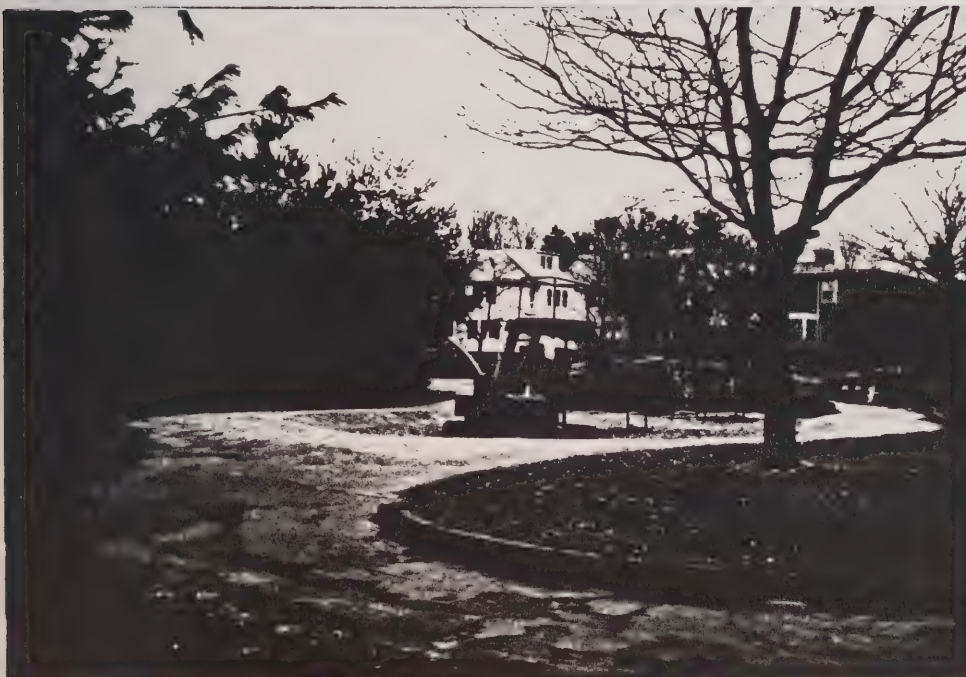
**Site Photograph 2**

Playground with white  
pine screen.

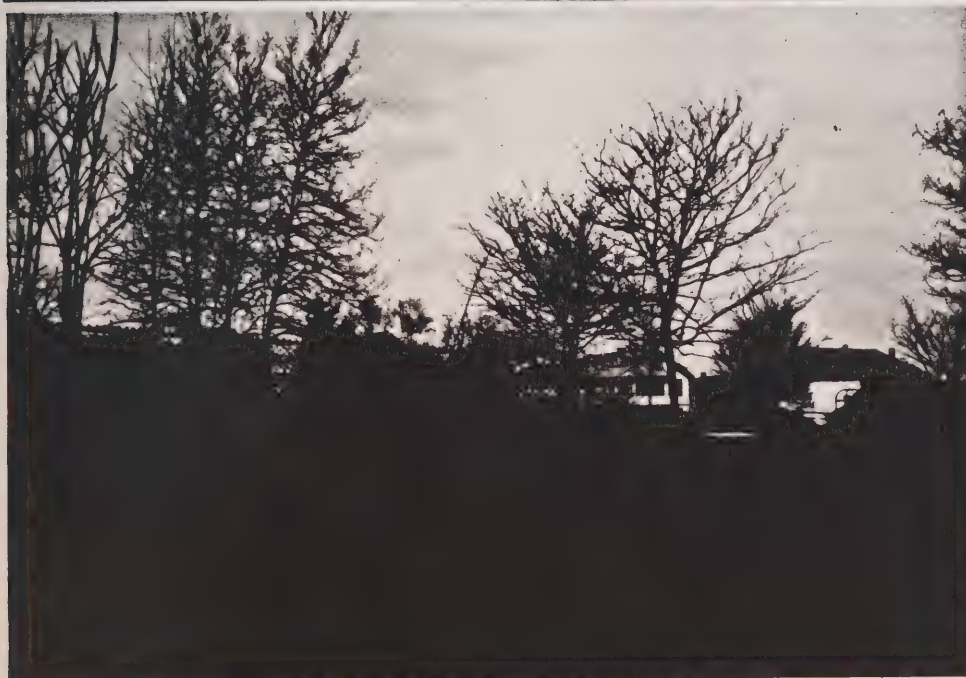
**Site Photograph 5**

View into site. Shows granite piece at entrance, weed growth to left.

The natural elements are in fair to good condition and require routine maintenance. Pruning of trees and shrubs, and removal of weed species, is needed.

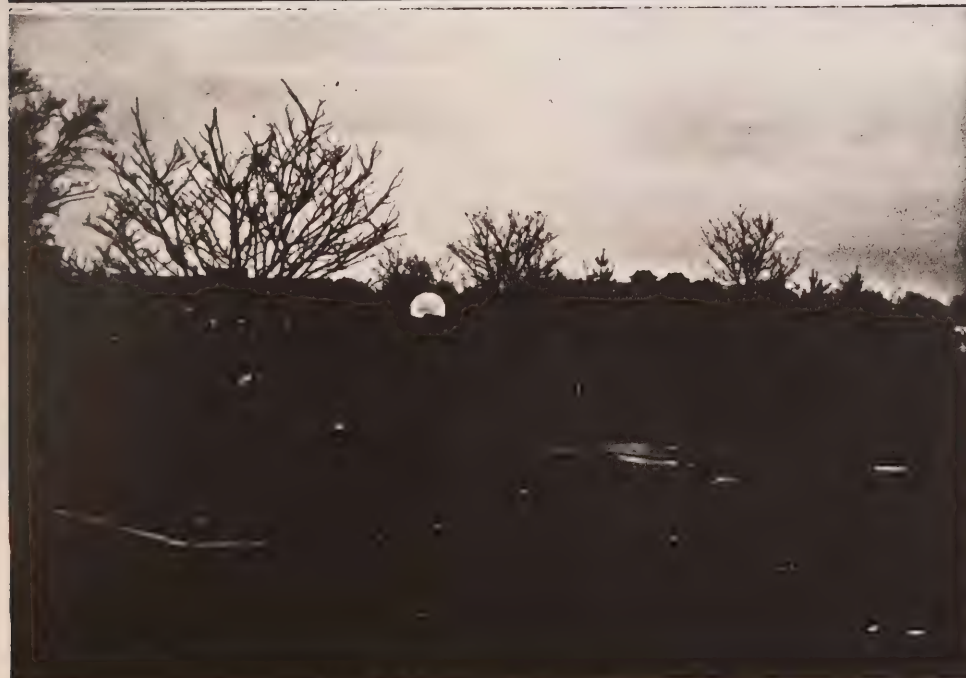
**Site Photograph 6**

Basketball/stickball area.

The condition of the sports facilities, the basketball court and stickball court area, is also fair to good. The playground is in good condition.

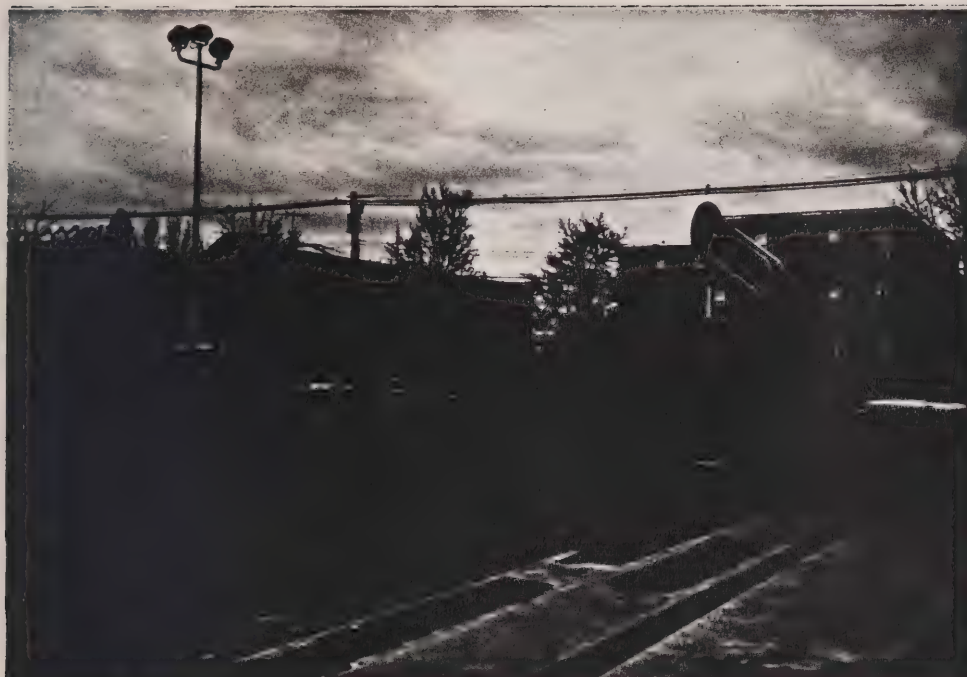
**Site Photograph 1**

Basketball court.  
Bleachers moved to  
block entrance.  
Character of neighbor-  
hood in background.

The basketball and tennis courts are in good condition, although fencing has been torn down. The ballfields are in fair condition, with badly worn turf in places.

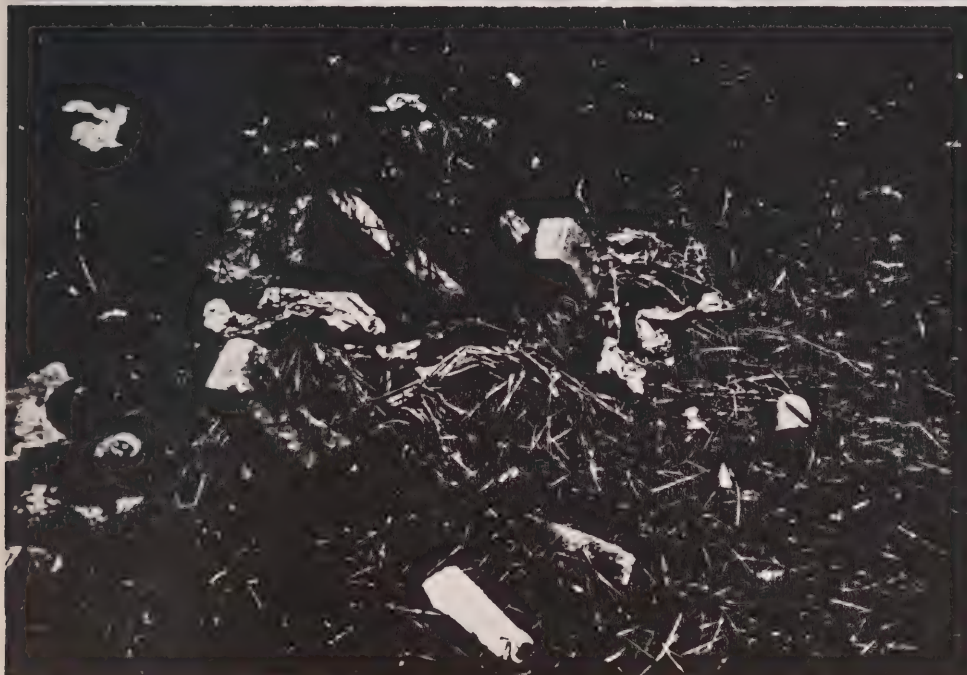
**Site Photograph 2**

Remains of bench,  
and litter.

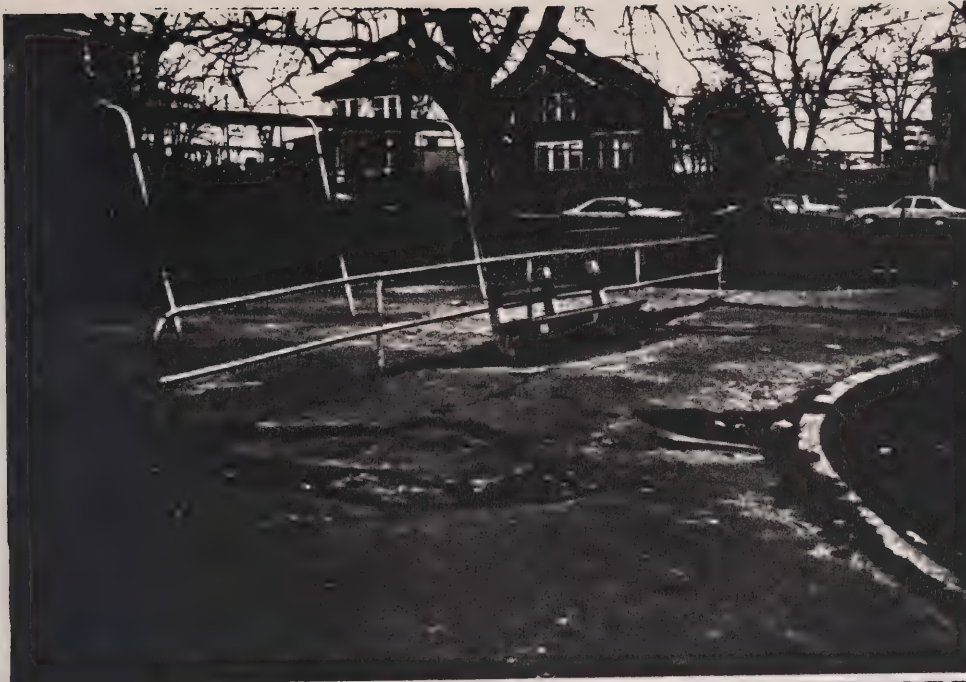
**Site Photograph 7**

Subsidence of pavement  
in play area.

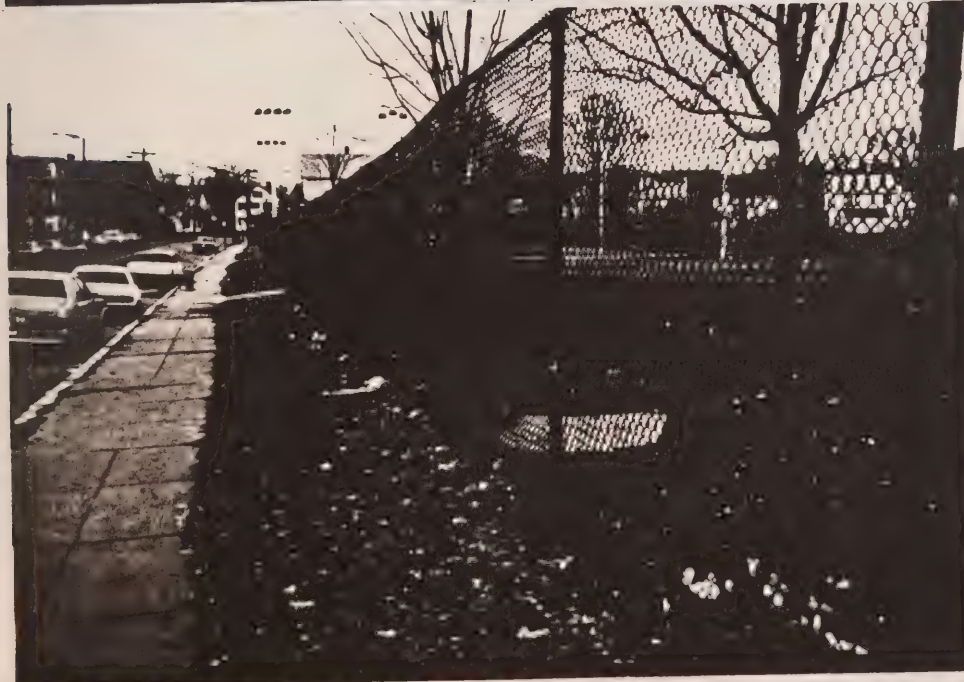
**Site Photograph 9**

Edge of park on Faneuil  
Street. Is fence  
necessary? Does it  
have to be so high?

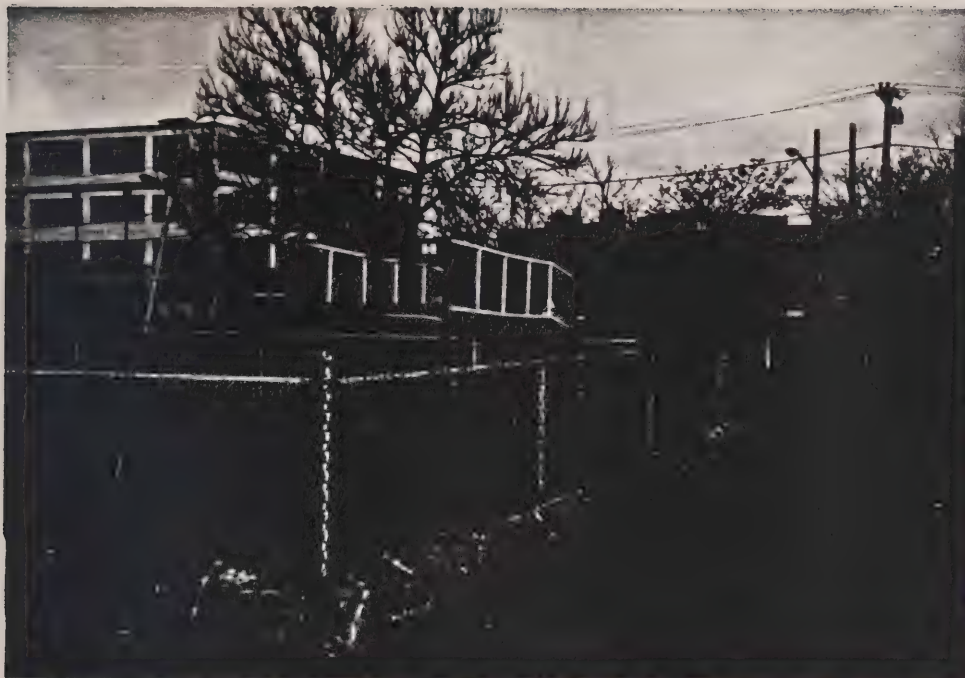
**Site Photograph 1**

Playground, showing  
fencing and curbing.

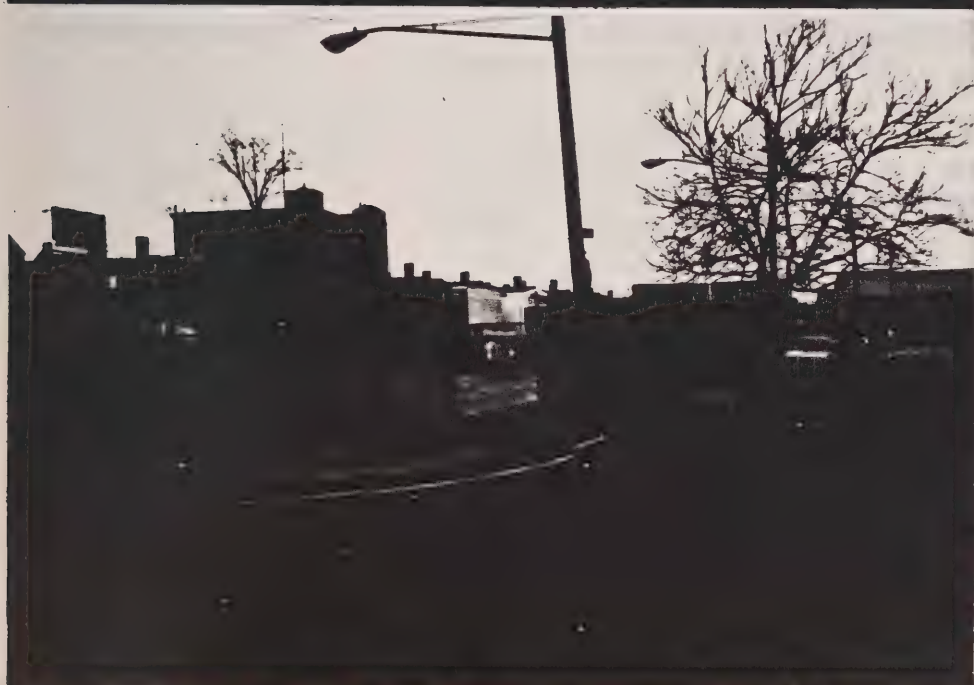
**Site Photograph 8**

Penniman Road.  
One good Sycamore on  
right.

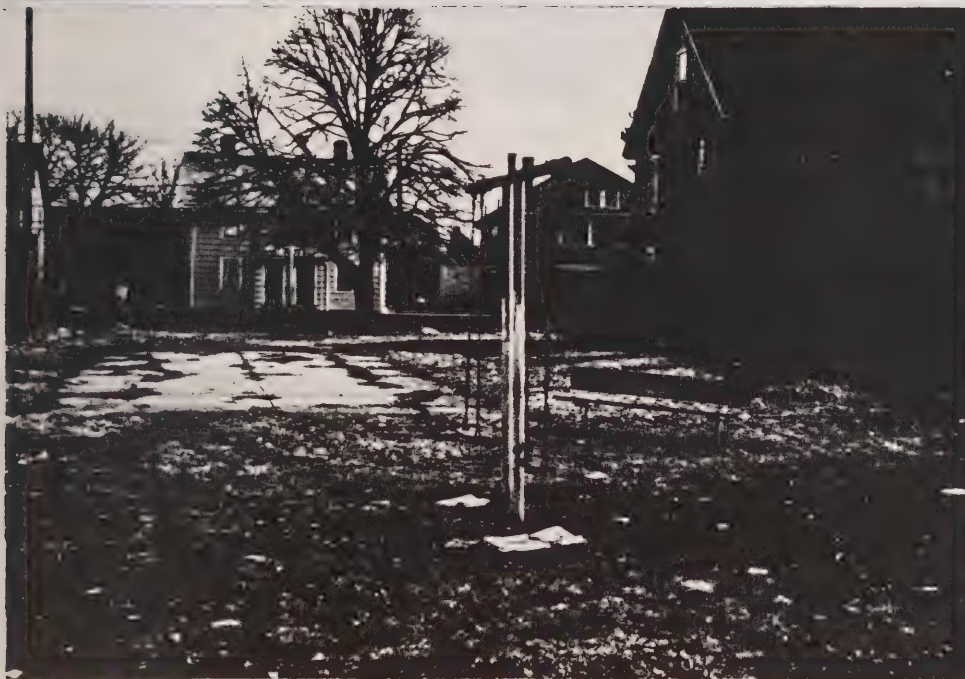
**Site Photograph 2**

Swings and bench.  
Concrete foundation.

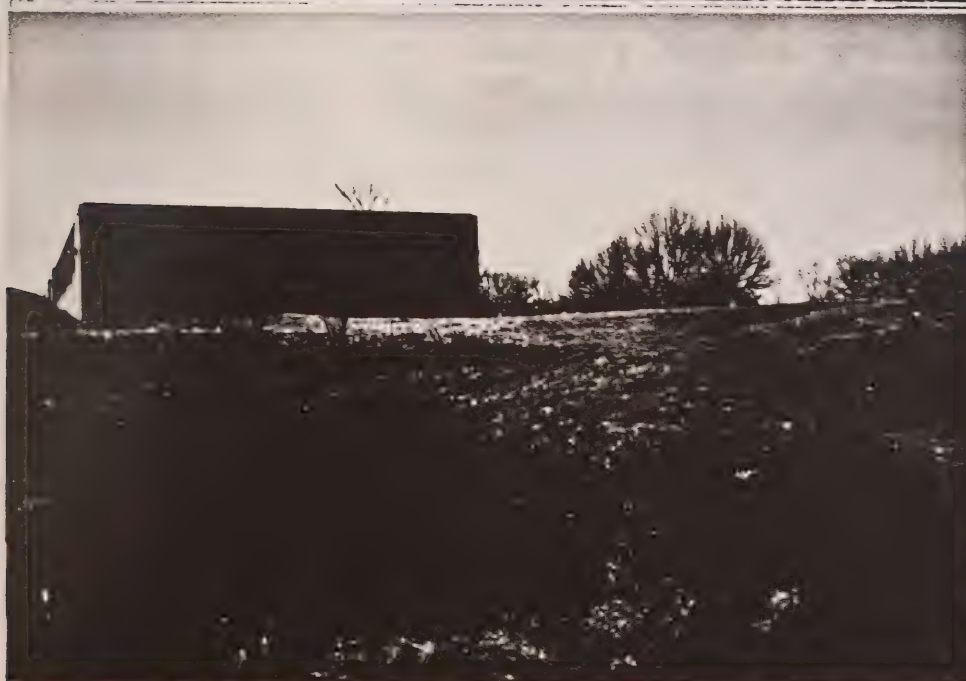
#### Site Photograph 6

West End House.
